ASSESSMENT OF STATUS OF BOMBED BRIDGES NORTH VIETNAM

CIA/PIR-5007/65

JUNE 1965

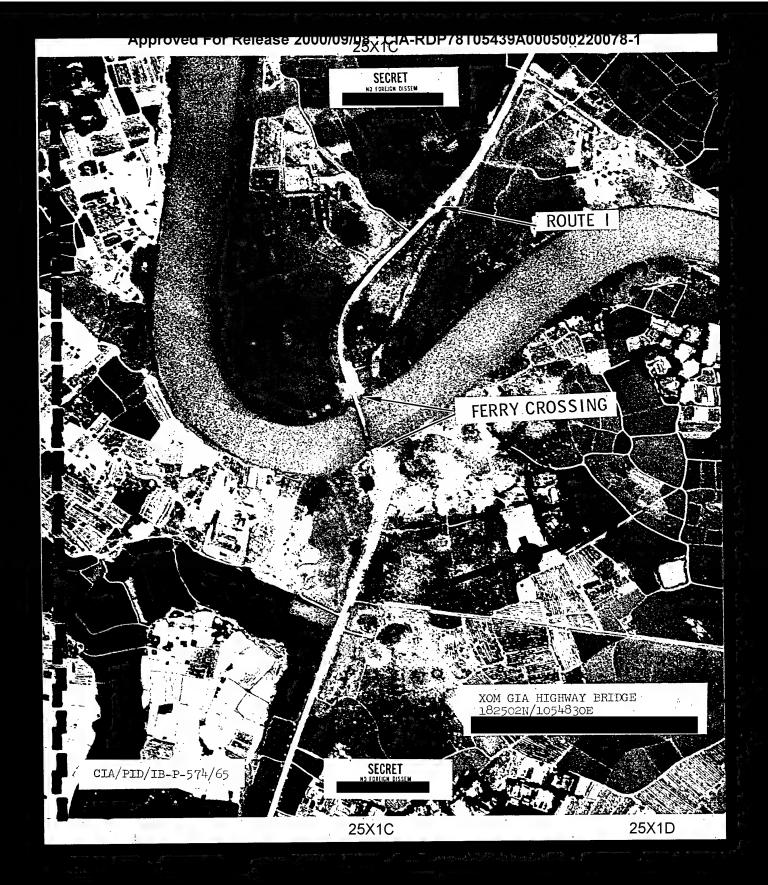
25X1C SECRET ROUTE I FERRY CROSSING THO SON HIGHWAY BRIDGE 182722N/1054643E 25X1D SECRET D FOREIGN DISSEN 25X1C

- I. The Son Highway Brigge (CIA/PID/IB-P-575/65)
 - 1. Status: One span destroyed, two spans superficially damaged
 - 2. Compensative Action: Newly constructed ferry crossing
- J. Tam Da Railroad & Highway Bridge (CIA/PID/IB-P-576/65)
 - 1. Status: Two spans destroyed, one span damaged, approaches damaged
 - 2. Compensative Action: Reactivated ferry crossing
- K. Ly Nhan Highway Bridge (CIA/PID/IB-P-577/65)
 - 1. Status: Approach cratered, two spans destroyed, one span severely damaged, one span moderately damaged, one span superficially damaged, and one pier severely damaged.
 - 2. Compensative Action: Reactivated ferry crossing
- L. Phuong Can Highway Bridge (CIA/PID/IB-P-578/65)
 - 1. Status: One span had been dropped. Dropped span has been replaced by temporary deck span for light traffic.
